**CONTINENTAL LIME
REVEGETATION REPORT**

April 9, 1997

The Cricket Mountain Plant, owned and operated by Continental Lime Inc., is an active limestone mine located south of Delta, Utah. Continental Lime Inc. is in the process of using a variety of treatments to revegetate limestone benches resulting from mining. Experimental test plot pairs are also present as well as topsoil stockpiles which are revegetating naturally. The objectives of the work reported here were to assess the current condition of the experimental test plots and benches and to evaluate the potential of naturally occurring species to revegetate future bench sites. Mr. Victor L. Kastner, Continental Lime's Quarry Supervisor, accompanied Dames & Moore personnel in the field to assure that all sites were accurately located.

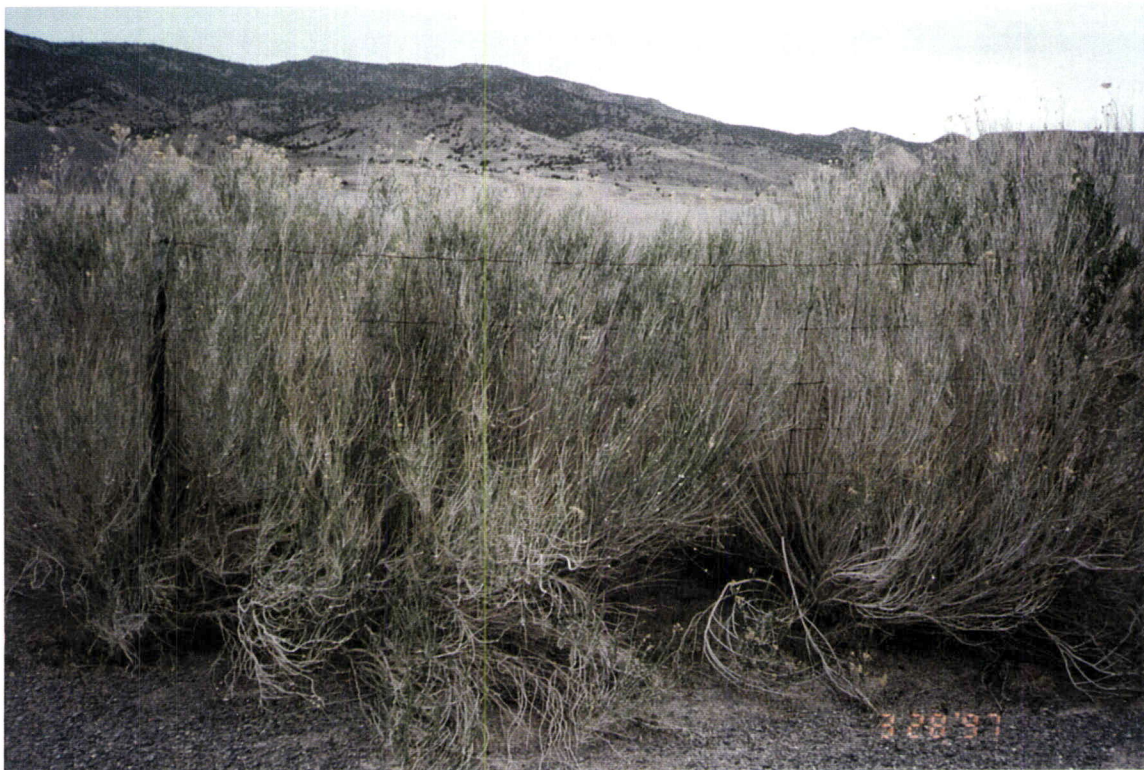
Photo 1. North Test Plot

The North test plot had approximately 90 percent cover of shrubs, grasses, and litter. Litter included rubber rabbitbrush leaves and seedheads. Seventy-five percent of the plot cover was

vigorous rubber rabbitbrush (See Photo 1). Five percent of the plot cover was provided by two small clumps of crested wheatgrass and scattered grasses coming up through the litter. Inside the plot fence, eight large (> 1 m), one small (< 0.5 m), and six sapling rubber rabbitbrush were present. In addition, five large and five small rubber rabbitbrush were present immediately adjacent to the plot.

The North and South test plots are isolated squares of vegetation on a sparsely vegetated bench. Although the upper layer of soil in the two plots appeared similar, it is probable that the more densely vegetated North plot received the mushroom compost treatment. From the March 1997 vegetation study it is apparent that on this substrate seeding alone resulted in shrub establishment and it is likely that seeding in conjunction with application of organic matter resulted in establishment of vigorous shrubs with successful reproduction.

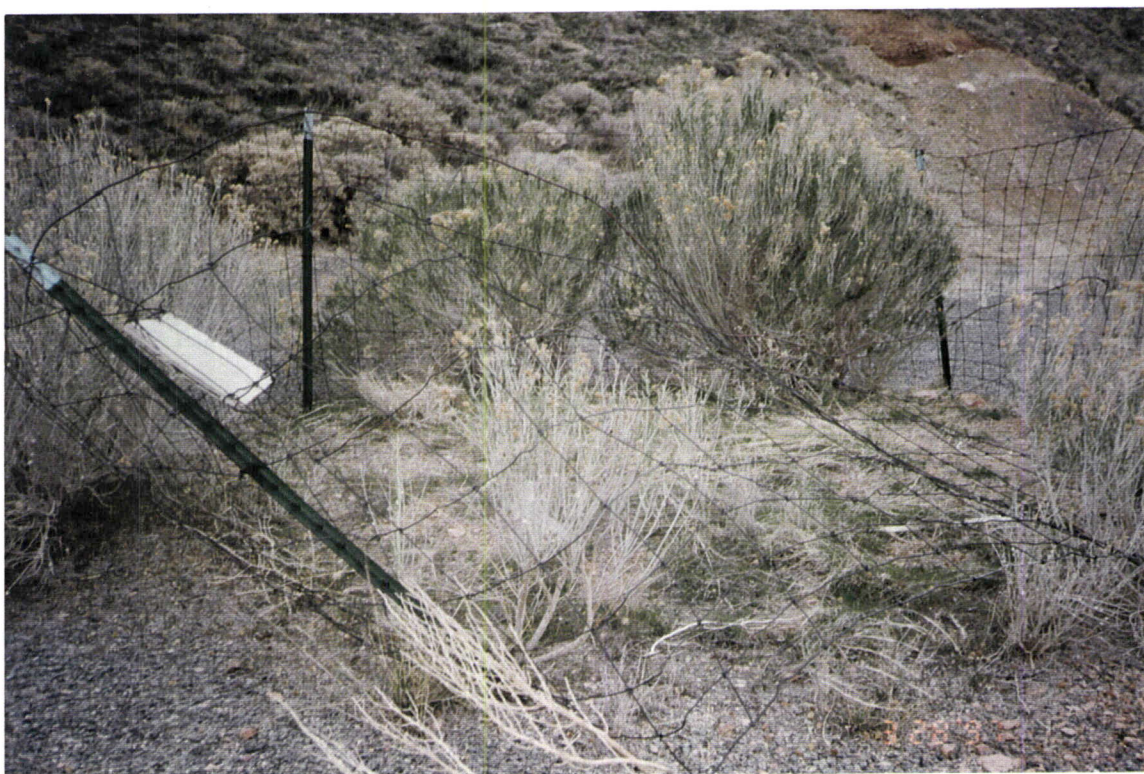
Photo 2. South Test Plot

The South test plot had approximately eighty percent cover of shrubs, grasses, and litter. Ten percent of the plot cover was of moderately vigorous rubber rabbitbrush and shadscale (*Atriplex confertifolia*) (See Photo 2). About fifty percent of the plot cover was grasses and about twenty percent of the plot cover was litter. Inside the plot fence, one large (> 1 m) rubber rabbitbrush, three small (< 0.5 m) rubber rabbitbrush, and two medium (< 0.5 to 1.0 m) shadscale were present. In addition, five large, one medium, two small, and seven very small (< 0.1 m) rubber rabbitbrush were present immediately adjacent to the plot.

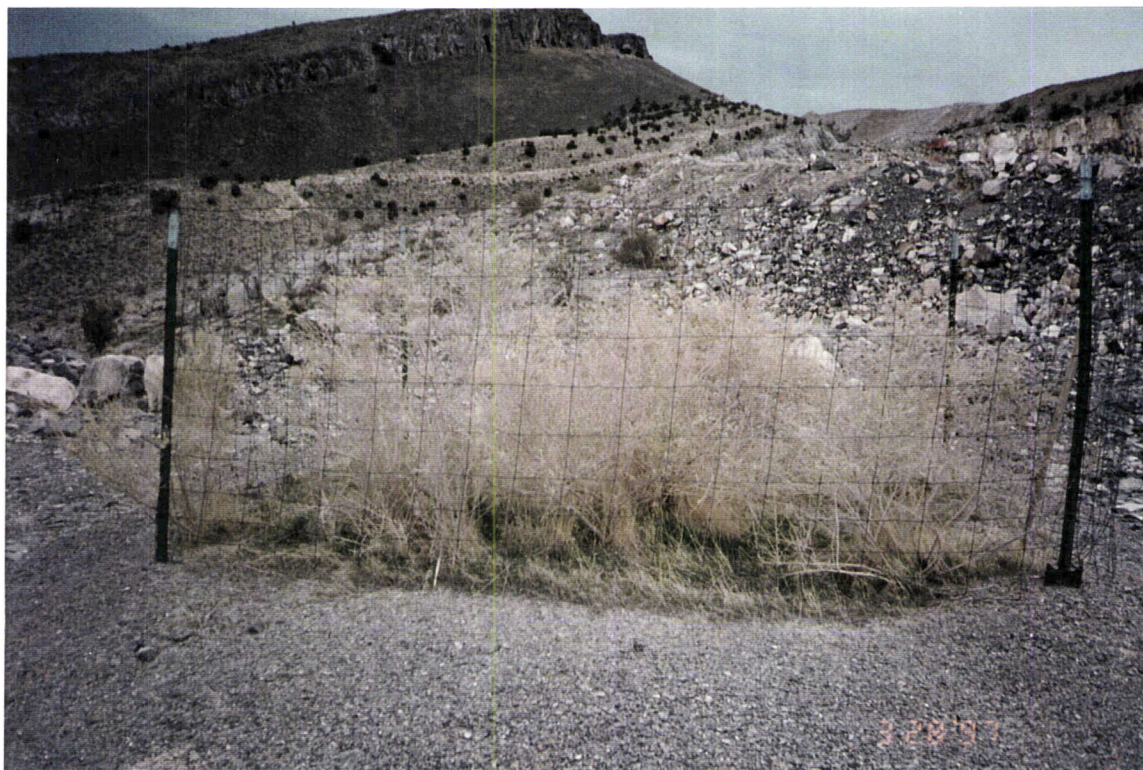
Photo 3. East Test Plot

The East test plot had approximately ninety percent cover by shrubs, grasses, and litter. Thirty percent of the plot cover was four-wing saltbush with low or very low vigor (Photo 3). About sixty percent of the plot cover was grasses and litter. Two clumps of seeded crested wheatgrass were present, but most grass cover was of cheatgrass (*Bromus tectorum*). Four medium (< 0.5 to 1.0 m), low vigor four-wing saltbush and five very small (< 0.1 m), very low vigor four-wing saltbush were present.

The East and West test plots are isolated squares of vegetation in an unvegetated flat depression. Although the upper layer of soil in the two plots appeared similar, it is probable that the more densely vegetated East plot received the mushroom compost treatment. From the March 1997 vegetation study it is apparent that on this substrate seeding alone resulted in some shrub establishment and it is likely that seeding in conjunction with application of organic matter results in establishment of a higher shrub and grass cover.

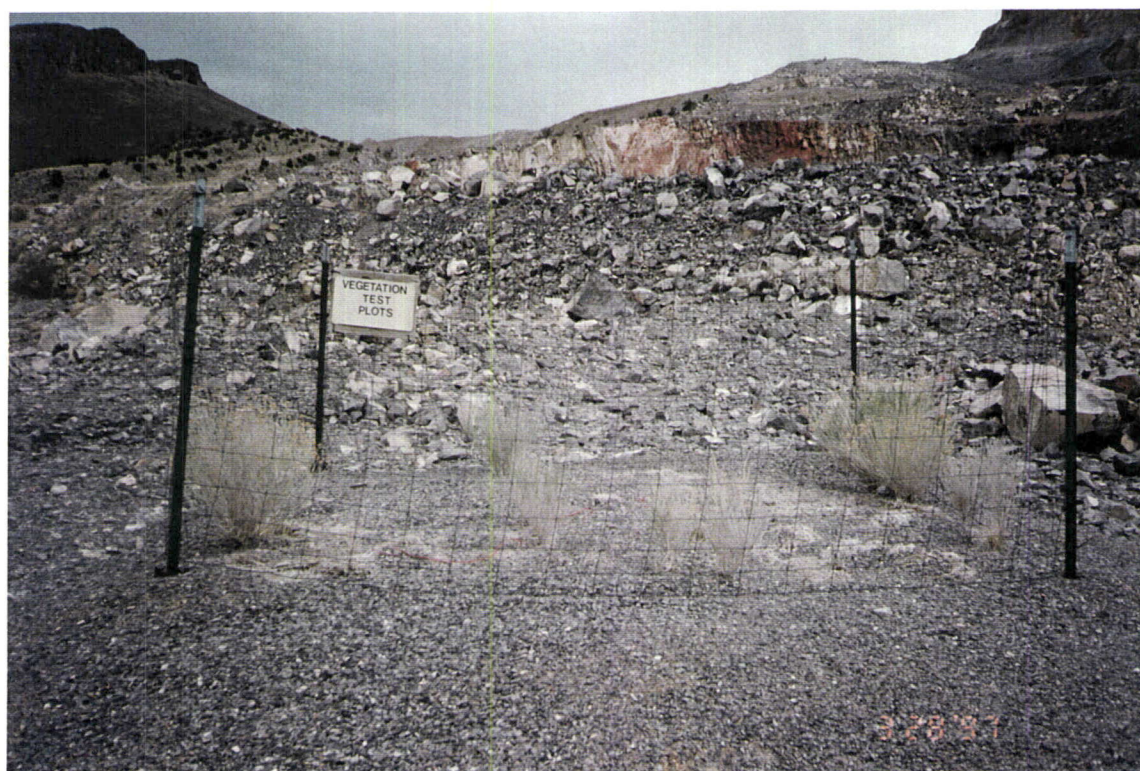
Photo 4. West Test Plot

The West test plot had approximately twenty percent cover comprised of shrubs, grasses and straw mulch. Ten percent of the plot cover was of medium vigor rubber rabbitbrush (Photo 4). About one percent of the plot cover was provided by one clump of crested wheatgrass and one clump of dormant grass and about ten percent of the plot cover was straw mulch. Four medium-small (about 0.5 m) and six small (< 0.5 m) rubber rabbitbrush were present as well as four very small (< 0.1 m) unidentified dead shrubs.

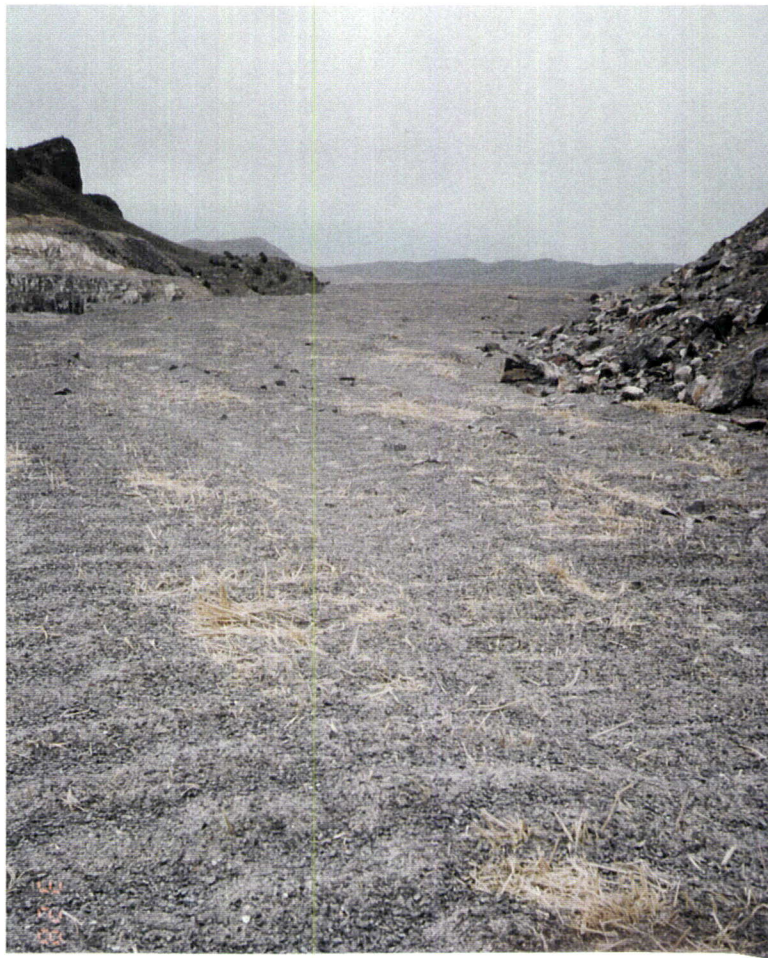
Photo 5. Bench 5960 W

Bench 5960 W had a growth media of limestone fines and received 1000 pounds per acre of straw mulch. Bulldozer tracks and small patches of crimped-in straw were visible (Photo 5). Vegetation consisted of one very small sprig of a goosefoot species from last year's growing season and one clump of grass (probably Russian wildrye), both in straw mulch at the north end of the bench.

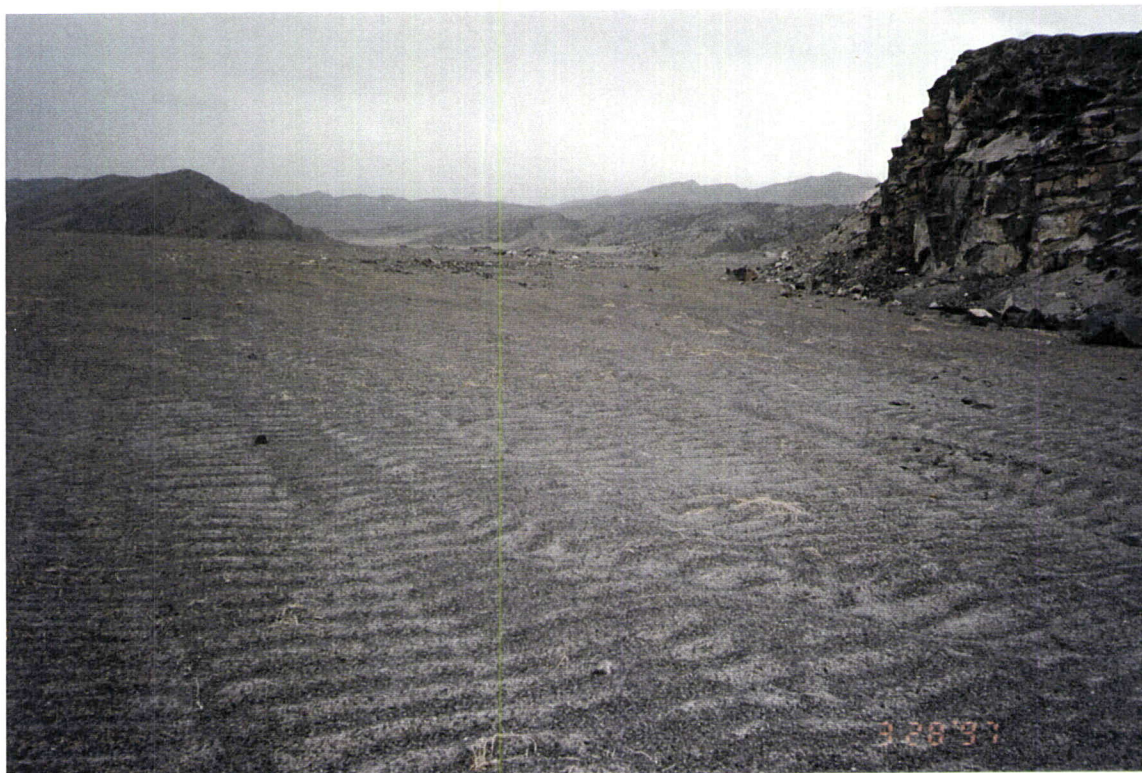
Photo 6. Bench 5940 W

Bench 5940 W had a growth media of limestone fines and received 1000 pounds per acre of hay mulch. Bulldozer tracks and small patches of crimped-in straw were visible (Photo 6). Vegetation was composed of two very small forbs, probably four-wing saltbush.

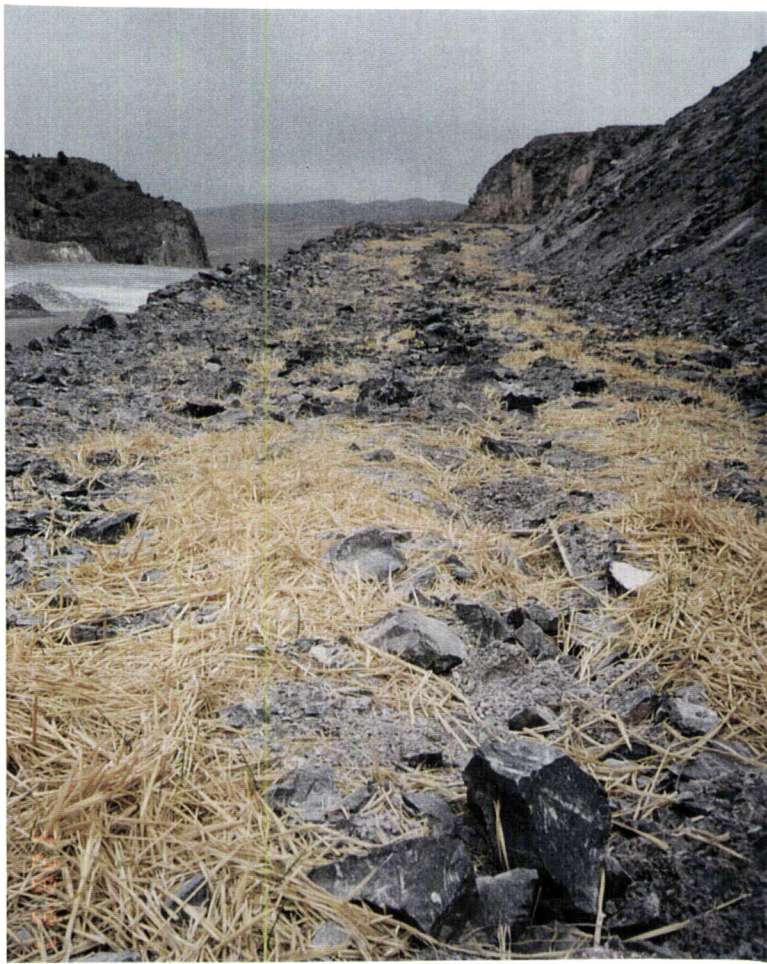
Photo 7. Bench 5920 W

Bench 5920 W received 3000 pounds per acre of straw mulch. Cobbles and boulders are present and about fifty percent of the surface is covered with straw mulch (Photo 7). A few clumps of Russian wildrye were present in areas of thick straw.

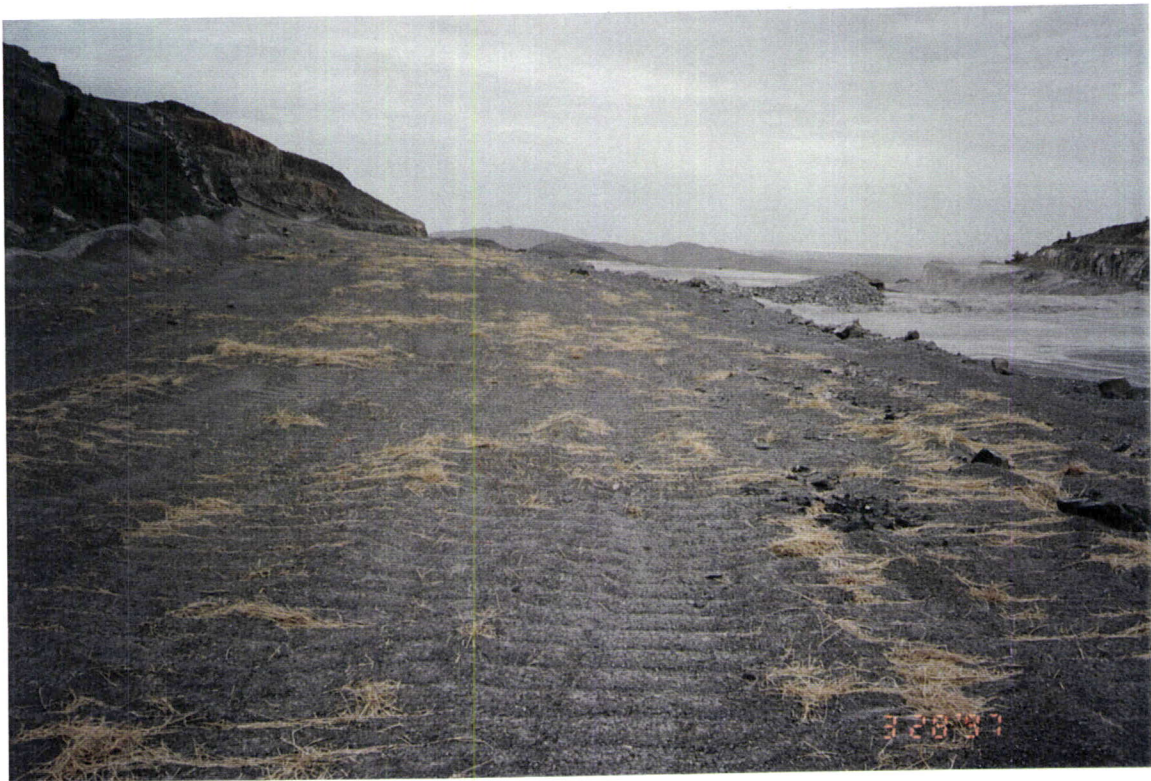
Photo 8. Bench 5900 W

Bench 5900 W received 2300 pounds per acre of straw mulch. Bulldozer tracks and small patches of crimped-in straw were visible (Photo 8). No vegetation was present.

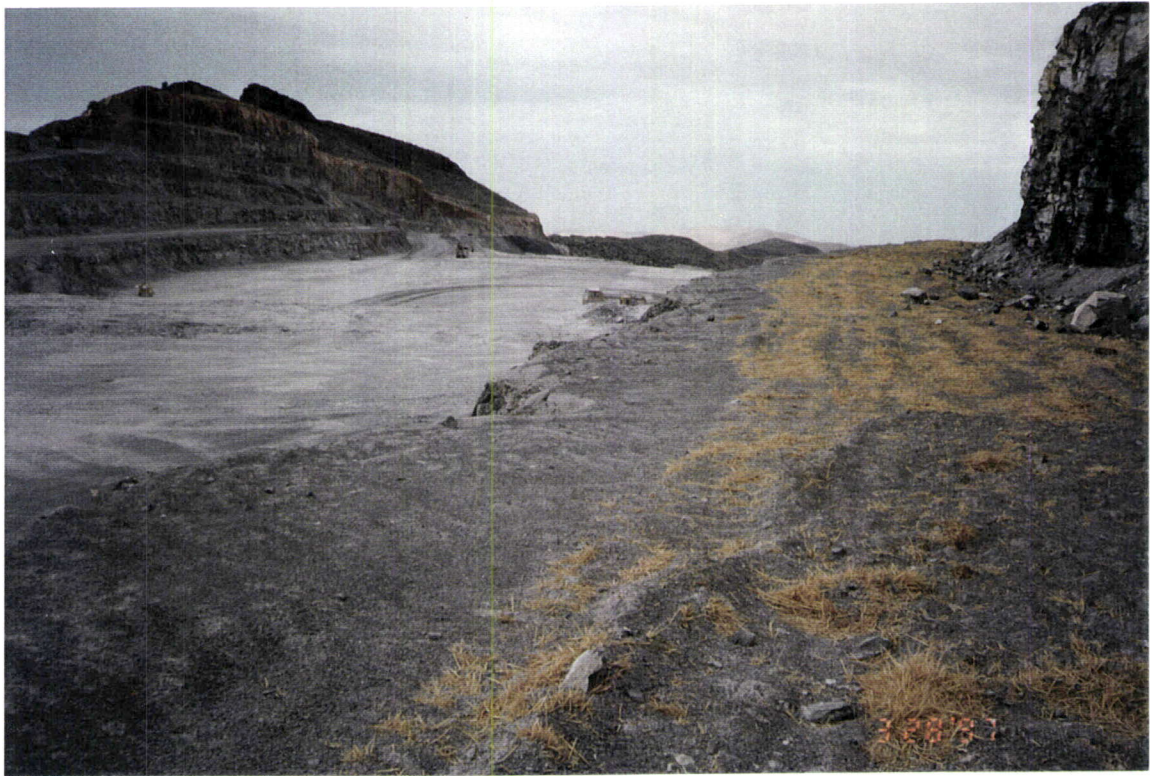
Photo 9. Bench 5900 E

Bench 5900 E received 1500 pounds per acre of straw mulch. Bulldozer tracks and patches of crimped-in straw were visible (Photo 9). A few grasses (probably Russian wildrye) were present in the thick straw at the north end.

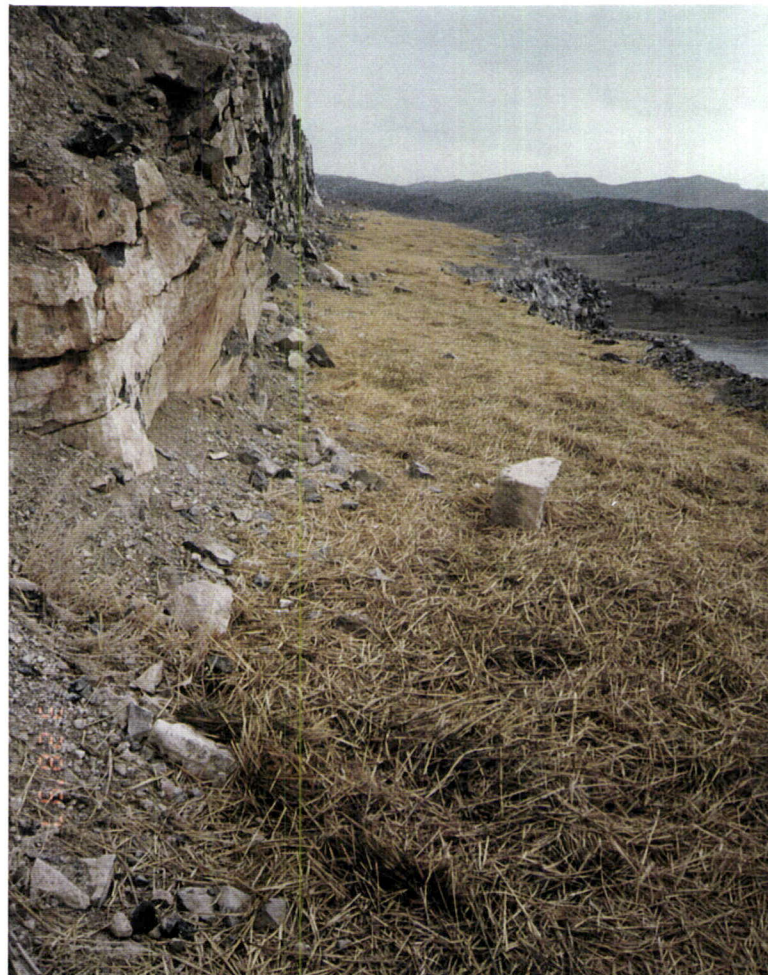
Photo 10. Bench 5940 E

Bench 5940 E received 2500 pounds per acre of straw mulch. A thick straw cover was present except at south end (Photo 10). A few scattered grasses (probably Russian wildrye) were present in the straw.

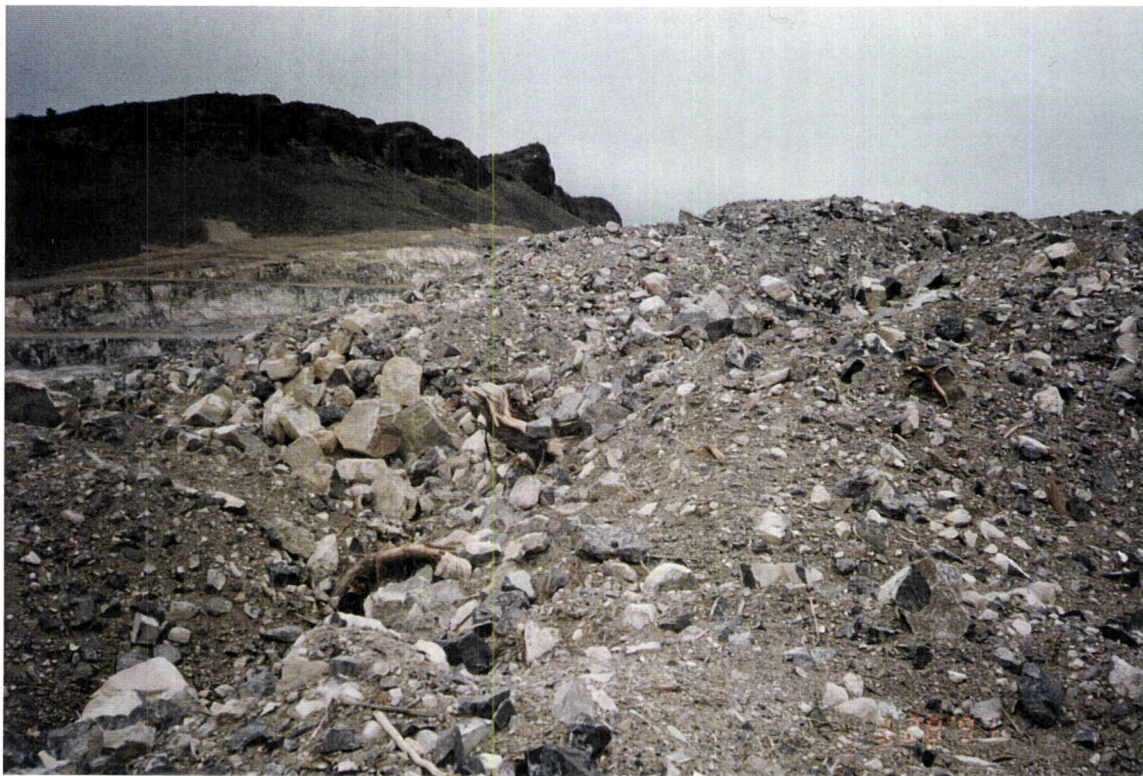
Photo 11. Topsoil Stockpile A

Upper PM is composed of piles of fines with cobbles, boulders, and juniper debris. Except for a very few widely scattered goosefoot (*Chenopodiaceae*) at the bottom of the west-facing slope, vegetation cover was 0 percent (Photo 11).

The topsoil stockpiles, except for Upper PM, were developing vegetation. On Upper PM it is likely that the lack of organic material and seeds combined with rapidly draining substrate have precluded vegetation cover. The shadscale and wheatgrass which invaded Lower PM are highly desirable revegetation species. Vegetation cover is approaching that of nearby undisturbed areas and it is likely that the lumpy microtopography caused by dumping of material has benefitted plant growth by creating moister, less windy microsites for seedling establishment. The adjacent native vegetation is one-seed juniper (*Juniperus osteosperma*) and sagebrush (*Artemisia* sp.) with Mormon tea (*Ephedra viridis*), phlox (*Phlox*) species and grasses. In contrast, PM Fines Topsoil, although more densely vegetated, has developed a more weedy vegetation cover. The adjacent undisturbed wide valley is vegetated with grasses (including cheatgrass), sagebrush, shadscale, and Mormon tea. Ungulate (possibly deer) tracks and droppings were present at the time of the survey. PM Crusher Topsoil has a lower vegetation cover than Piles B and C which may be due to more recent construction.

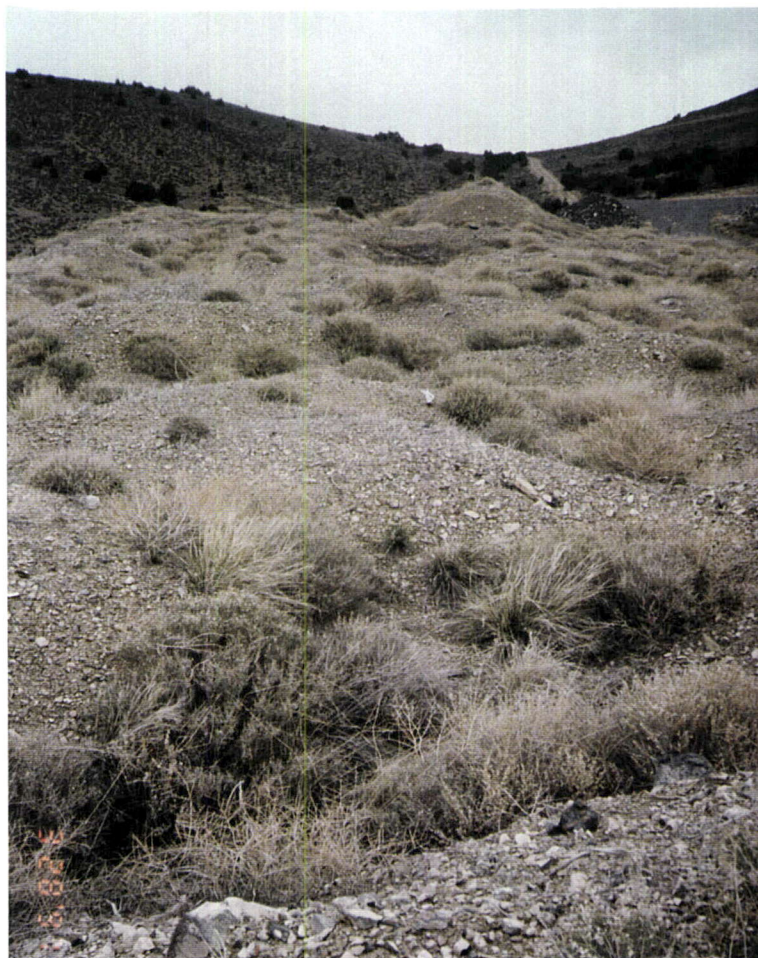
Photo 12. Topsoil Stockpile B

Lower PM has about eighty percent vegetation and litter cover. Shadscale is the dominant shrub. Clumps of cheatgrass and wheatgrass (*Agropyron* sp.) are present as well as a tall mustard species (probably tumble mustard [*Sisymbrium altissium*]), Russian thistle (*Salsola* sp.), and a goosefoot species (probably *Kochia*) (Photo 12).

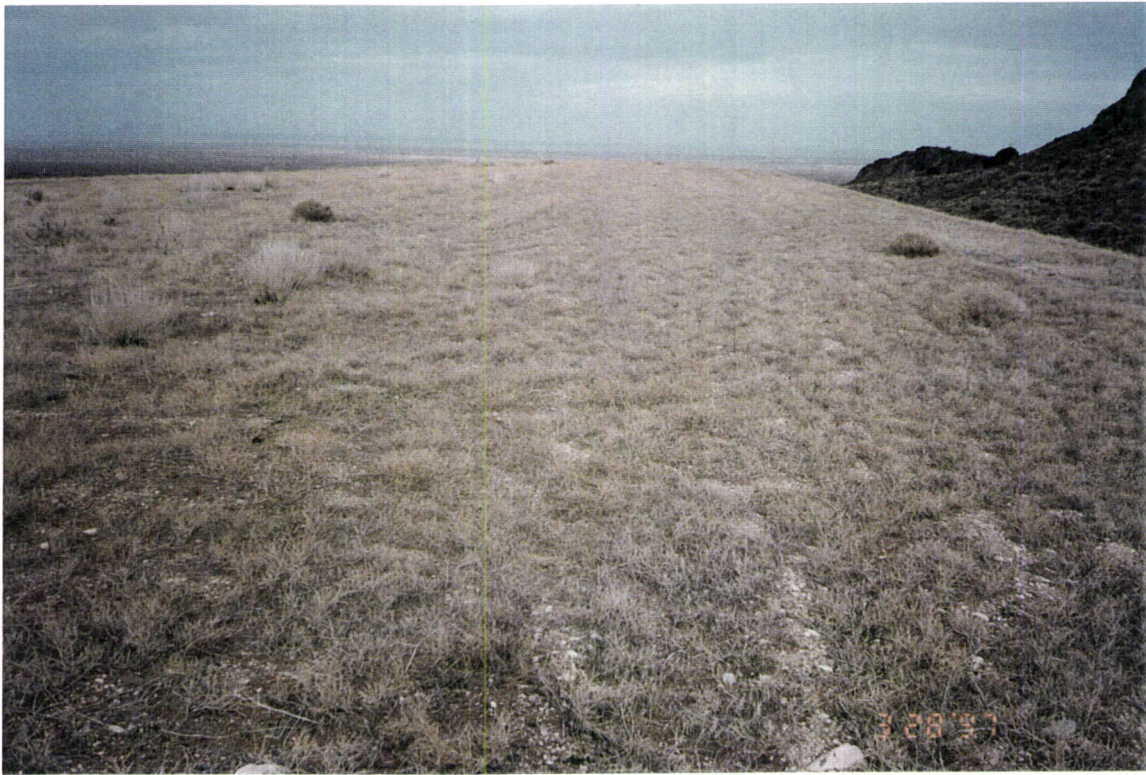
Photo 13. Topsoil Stockpile C

PM Fines Topsoil has about ninety percent vegetation cover. The dominant species is a tall mustard (probably tumble mustard) with widely scattered shadscale, winterfat and some grasses (Photo 13).

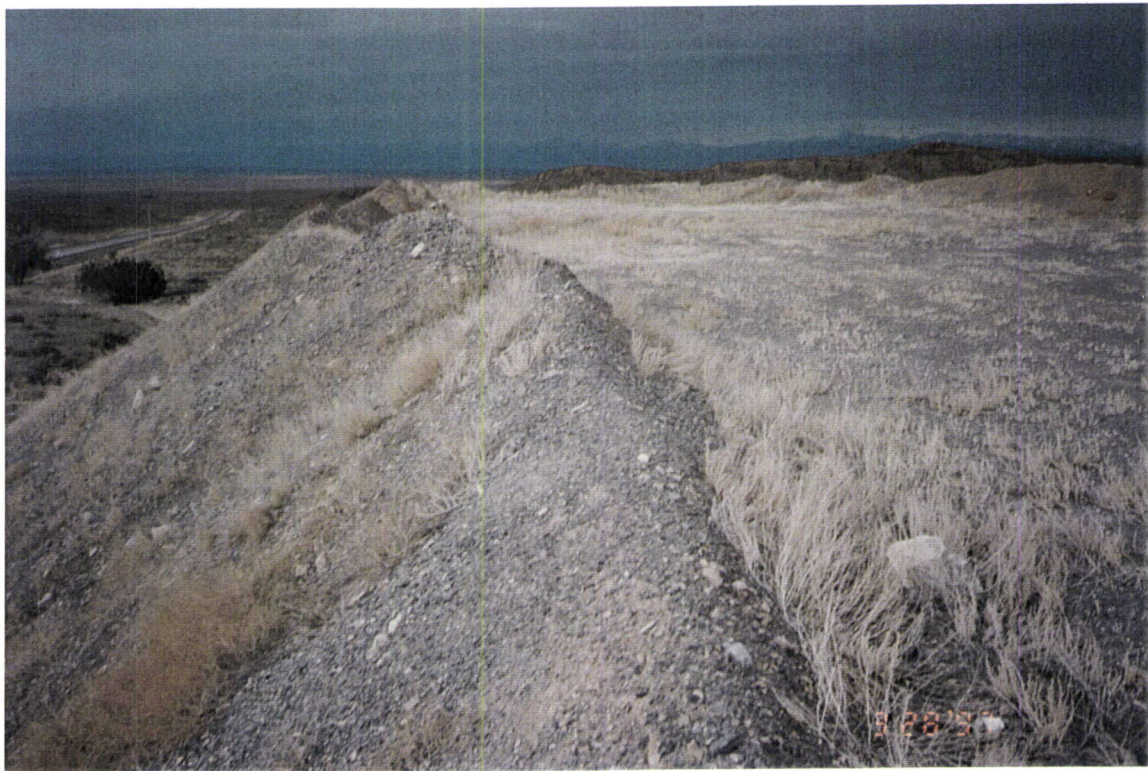
Photo 14. Topsoil Stockpile D

PM Crusher Topsoil has with about 50 percent vegetation cover. The dominant species is a goosefoot forb with some grasses, Russian thistle, cheatgrass, wheatgrass, mustard species (Photo 14).
